Manhole Inspection Summary

Manhole # S49EE_009MH

Insp Date: **7/15/08 12:19 PM**

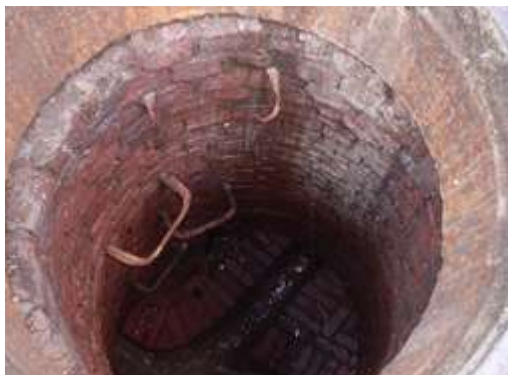
Defect 1

Condition: ☐ Sound ☐ Cracked ☐ Root Intrusion ☒ **Loose Brick** ☐ Deteriorated

Infiltration: ☐ None ☒ **Joint** ☐ Cracks ☒ **Mortar** ☐ Roots ☐ Wall

infiltration

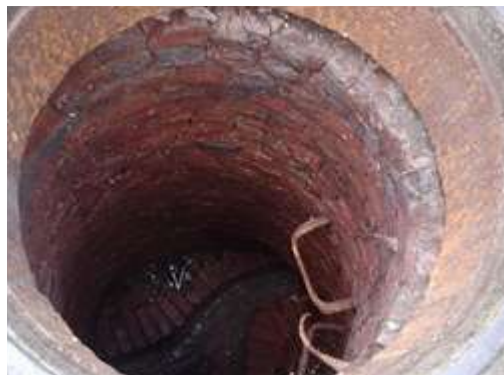
Defect 2

frame leaks

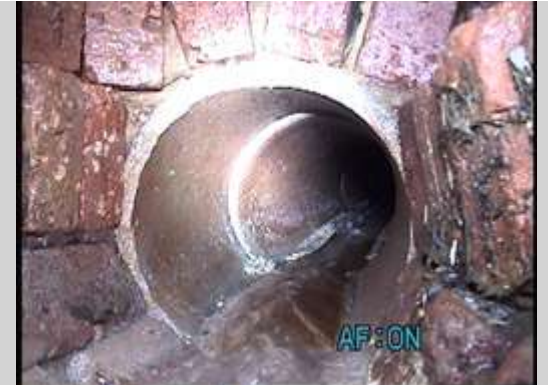
12 O'Clock Outflow

8 in. Circular Gravity Sewer
Pipe Out @ 12 O'Clock

Pipe Height: **8.4** (in.) Rod and Bar (Angled)
Pipe Material: **Clay** ☐ Pipe Lined
Invert Depth: **10.25** (ft.) Flow Characteristics: **Fast**
Deposits: ☒ None ☐ Mud ☐ Sludge ☐ Debris ☐ Grease
Silt Depth: (in.) Deposits Extent:
Infiltration: **None** Pipe Seal Cond: **Sound**

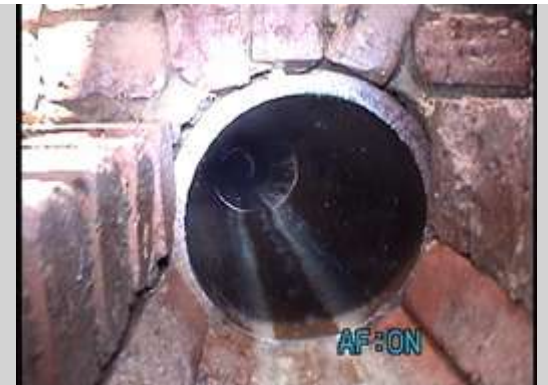
3 O'Clock Inflow

8 in. Circular Gravity Sewer
Pipe In @ 3 O'Clock

Pipe Height: **8.4** (in.) Rod and Bar (Angled)
Pipe Material: **Clay** ☐ Pipe Lined
Invert Depth: **9.55** (ft.) Flow Characteristics: **Fast**
Deposits: ☒ None ☐ Mud ☐ Sludge ☐ Debris ☐ Grease
Silt Depth: (in.) Deposits Extent:
Infiltration: **None** Pipe Seal Cond: **Sound**

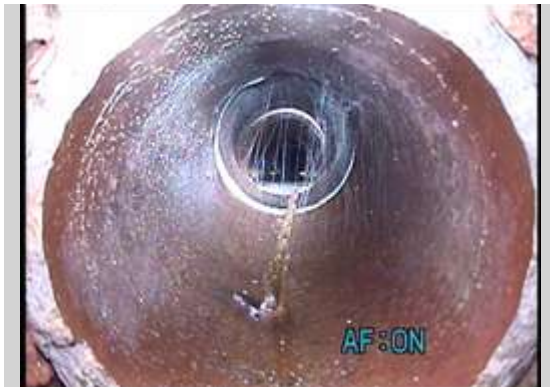
6 O'Clock Inflow

Pipe In @ 6 O'Clock

Infiltration: **None** Pipe Seal Cond: **Sound**

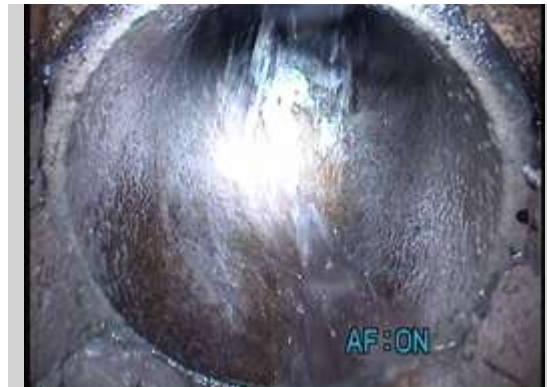
Drop In @ 6 O'Clock

Drop: Inside	Rod and Bar
Angled: Yes	Reading: 8.70 (ft.)
	Inv Depth: 9.70 (ft.)
Drop Condition: Open
